THESIS

6 AN EXPERIMENTAL STUDY TO DETERMINE THE REDUCTION  
IN ULTIMATE BENDING MOMENT OF A COMPOSITE PLATE  
DUE TO AN INTERNAL DELAMINATION.

11 December 1977

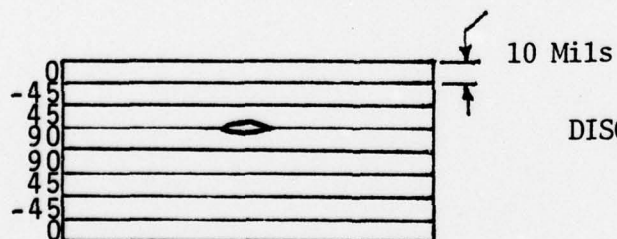
Fig 1 - Typical Layup Configuration

The internal delaminations were created by the insertion of an extremely thin non-porous teflon membrane between the laminae during the preparation of each specimen as depicted in Figure 1.\* All delaminations were circular, so as not to bias any propagation of the delaminations in any particular direction, and either 1/2-inch or 1-inch in diameter.

DISC = 1 Mil Teflon

Each composite plate prepared was originally 16 inches square. It was then cut using a diamond edged circular saw into six test specimens. Each specimen was rectangular in shape, 4 inches in width, and 7 inches in length. A typical delamination was located in the plate as depicted in Figure 1.
